Contract #: 04-0120F4Cty: SF/ALA Rte: 80 PM: 13.2/13.9File #: 13.28**WELDING INSPECTION REPORT****Resident Engineer:** Pursell, Gary**Address:** 333 Burma Road**City:** Oakland, CA 94607**Report No:** WIR-012482**Date Inspected:** 05-Mar-2010**Project Name:** SAS Superstructure**OSM Arrival Time:** 1000**Prime Contractor:** American Bridge/Fluor Enterprises, a JV**OSM Departure Time:** 1830**Contractor:** Oregon Iron Works Clackamas, Or.**Location:** Clackamas, OR**CWI Name:** M. Gregson, J. Salazar**CWI Present:** Yes No**Inspected CWI report:** Yes No N/A**Rod Oven in Use:** Yes No N/A**Electrode to specification:** Yes No N/A**Weld Procedures Followed:** Yes No N/A**Qualified Welders:** Yes No N/A**Verified Joint Fit-up:** Yes No N/A**Approved Drawings:** Yes No N/A**Approved WPS:** Yes No N/A**Delayed / Cancelled:** Yes No N/A**Bridge No:** 34-0006**Component:** Hinge K Pipe Beams**Summary of Items Observed:**

Hinge-K Pipe Beam Assembly 102A-2:

Hinge-K Pipe Beam Assembly 102A-1:

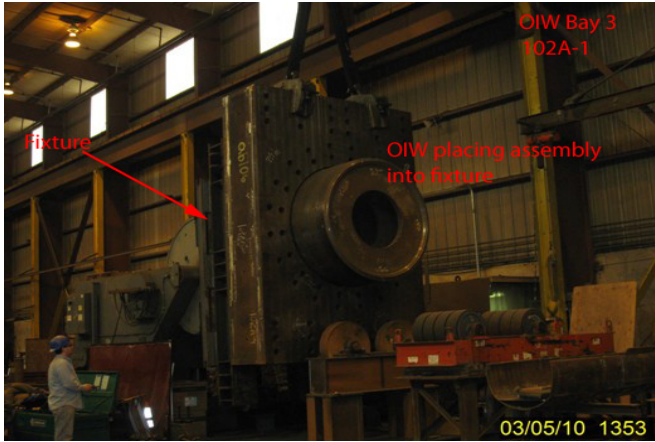
The QA Inspector witnessed OIW production personell, Troy Smith, Marc Belgrade and Darren Dozier placing the assembly 102A-1 in the welding fixture. The QA Inspector noted that the assembly was being placed, in preparation for the future fit-up of the fuse. See attached pictures below.

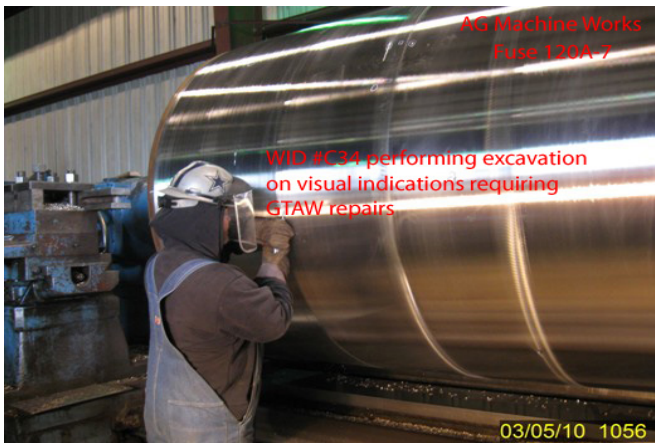
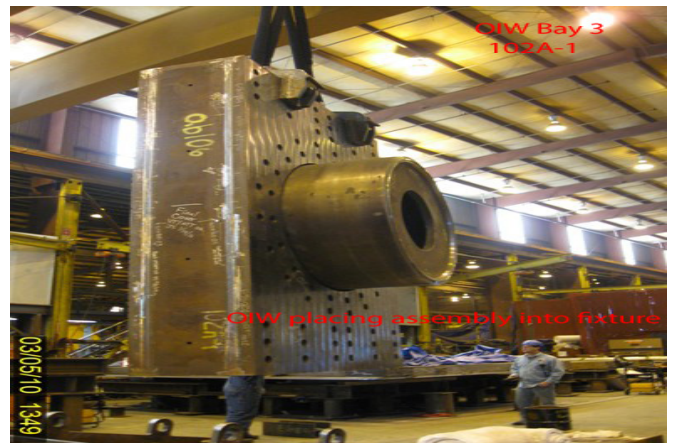
On this date, the QA Inspector arrived at AG Machine to observe OIW perform the weld repairs, on the previously discovered indications on the finished overlay surface, on this Fuse 120A-7. The QA Inspector met with OIW QC Inspector Jose Salazar, OIW welder (WID# C34) Mark Craig and an AG Machinist. QC Inspector Salazar explained to the QA Inspector that he was instructed to perform visual testing (VT) on 100% of the overlay and WID #C34 will then perform the GTAW weld repairs. The QA Inspector noted that the indications, currently present in the overlay, appeared after AG completed the 2nd final cut pass, for final machining and appeared to be small clusters of slag inclusions. The QA Inspector witnessed QC Inspector Salazar performing VT on the overlay surface and marking up surface discrepancies and indications, for weld repairs. QC Inspector Salazar then explained to the QA Inspector that the indications were measured at varying lengths from 1mm to 150 mm and no wider than 6 mm. The QA Inspector then witnessed WID #C34 grinding out these previously marked indications, to a depth no greater than 3 mm and then later setting up to perform the GTAW.

The QA Inspector noted that WID #C34 was currently qualified to perform these repairs and would be utilizing welding procedure specification (WPS 8022). The QA Inspector witnessed the AG Machinist rotating the fuse assembly to access the weld repair areas in the flat position. The QA Inspector then witnessed WID #C34, performing the pre-heat required, utilizing a torch and then observed a temperature of approximately 175 degrees Fahrenheit, after the pre-heat was complete. The QA Inspector noted that 125 degrees Fahrenheit minimum was required, per WPS 8022. The QA Inspector then observed WID #C34 performing the GTAW on the previously excavated repair areas. The QA Inspector also observed QC Inspector Jose Salazar recording the in-process welding parameters of 124 amps, 16 volts and travel speed of 4 inches per minute (i.p.m.). The QA Inspector also verified these welding parameters. The QA Inspector then observed the AG Machinist rotating the Fuse, to access several more excavations, that would need to go through the above mentioned repair procedure. The QA Inspector observed that Mr. Salazar was present the entire time in which the GTAW welding was being performed. The QA Inspector was then informed by the AG Machinist and QC Inspector Salazar that the repairs will not be ground flush after completed. The AG Machinist explained that an additional cut pass will be required, approximately .5 mm deep, that will machine flush these weld repair areas, then finish honing will start. QC Inspector Salazar explained that 100% Visual and Penetrant Testing (VT/PT) will then be completed and any other additional surface discrepancies and indications, will then be marked up and possibly GTAW repaired. See attached pictures below.
